FORD:
2005-2009 Escape Hybrid, Escape

MERCURY:
2005-2009 Mariner
2006-2009 Mariner Hybrid

TSB 09-4-4 (Continued)

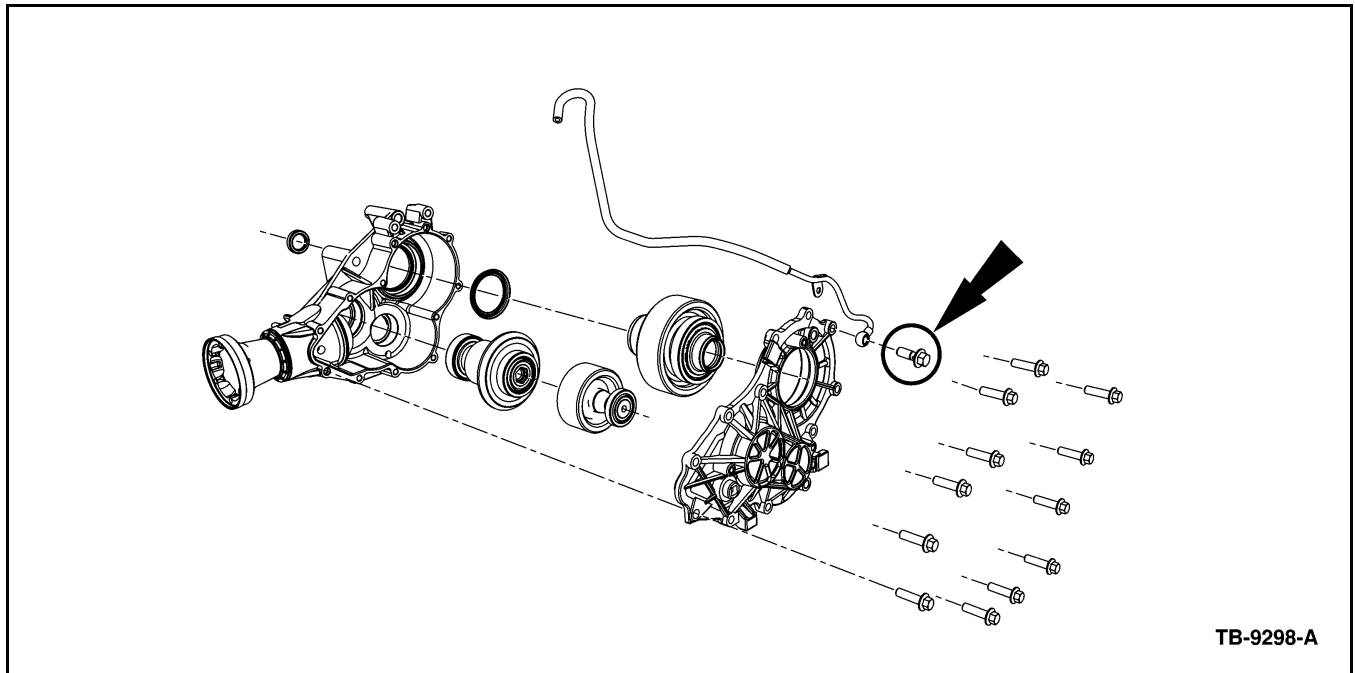
Figure 1 - Article 09-4-4

Some 2005-2009 Escape, Mariner, Escape Hybrid and 2006-2009 Mariner Hybrid vehicles may exhibit a leak from the power transfer unit (PTU) vent tube bolt. This may be misdiagnosed as a PTU link shaft seal leak. Please verify leak origin and tighten PTU vent tube bolt, before replacing parts.

2. Inspect PTU vent tube bolt for leak. (Figure 1)

- a. If PTU vent tube bolt leaking - clean bolt contact surfaces and torque bolt to 120 ± 19 lb-in (13.5 ± 2.1 N•m).
- b. If PTU vent tube bolt not leaking - continue with normal WSM, Section 308-07B diagnosis.

THIS BOLT DOES NOT REQUIRE A WASHER FOR THIS APPLICATION.
