MODEL/YEAR MODÈLE /ANNÉE	DATE OF ISSUE DATE EN VIGUEUR	BULLETIN NUMBER NUMÉRO DU BULLETIN
2006-08 CIVIC HYBRID	AUG. 6, 2010	IV-7-10
Rev. Nov. 16/10 - Information marked by black bars

PRODUCT UPDATE: NEW SOFTWARE TO HELP PREVENT IMA BATTERY DETERIORATION

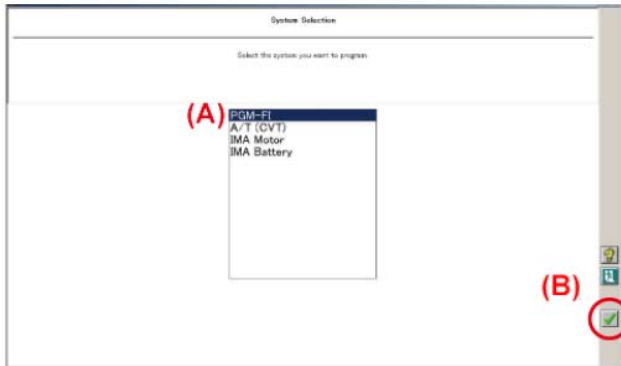
To further reduce the risk of damaging the PCM during the update, it is recommended that you attach a *Power Supply Charger* to the battery (refer to *Tools Bulletin II-2-08, Midtronics PSC-550S Power Supply Charger for instructions*).
