EC10-005a

NTB10-056a

June 25, 2010

2007 – 2010 ALTIMA HYBRID; DTC P0300 – P0304

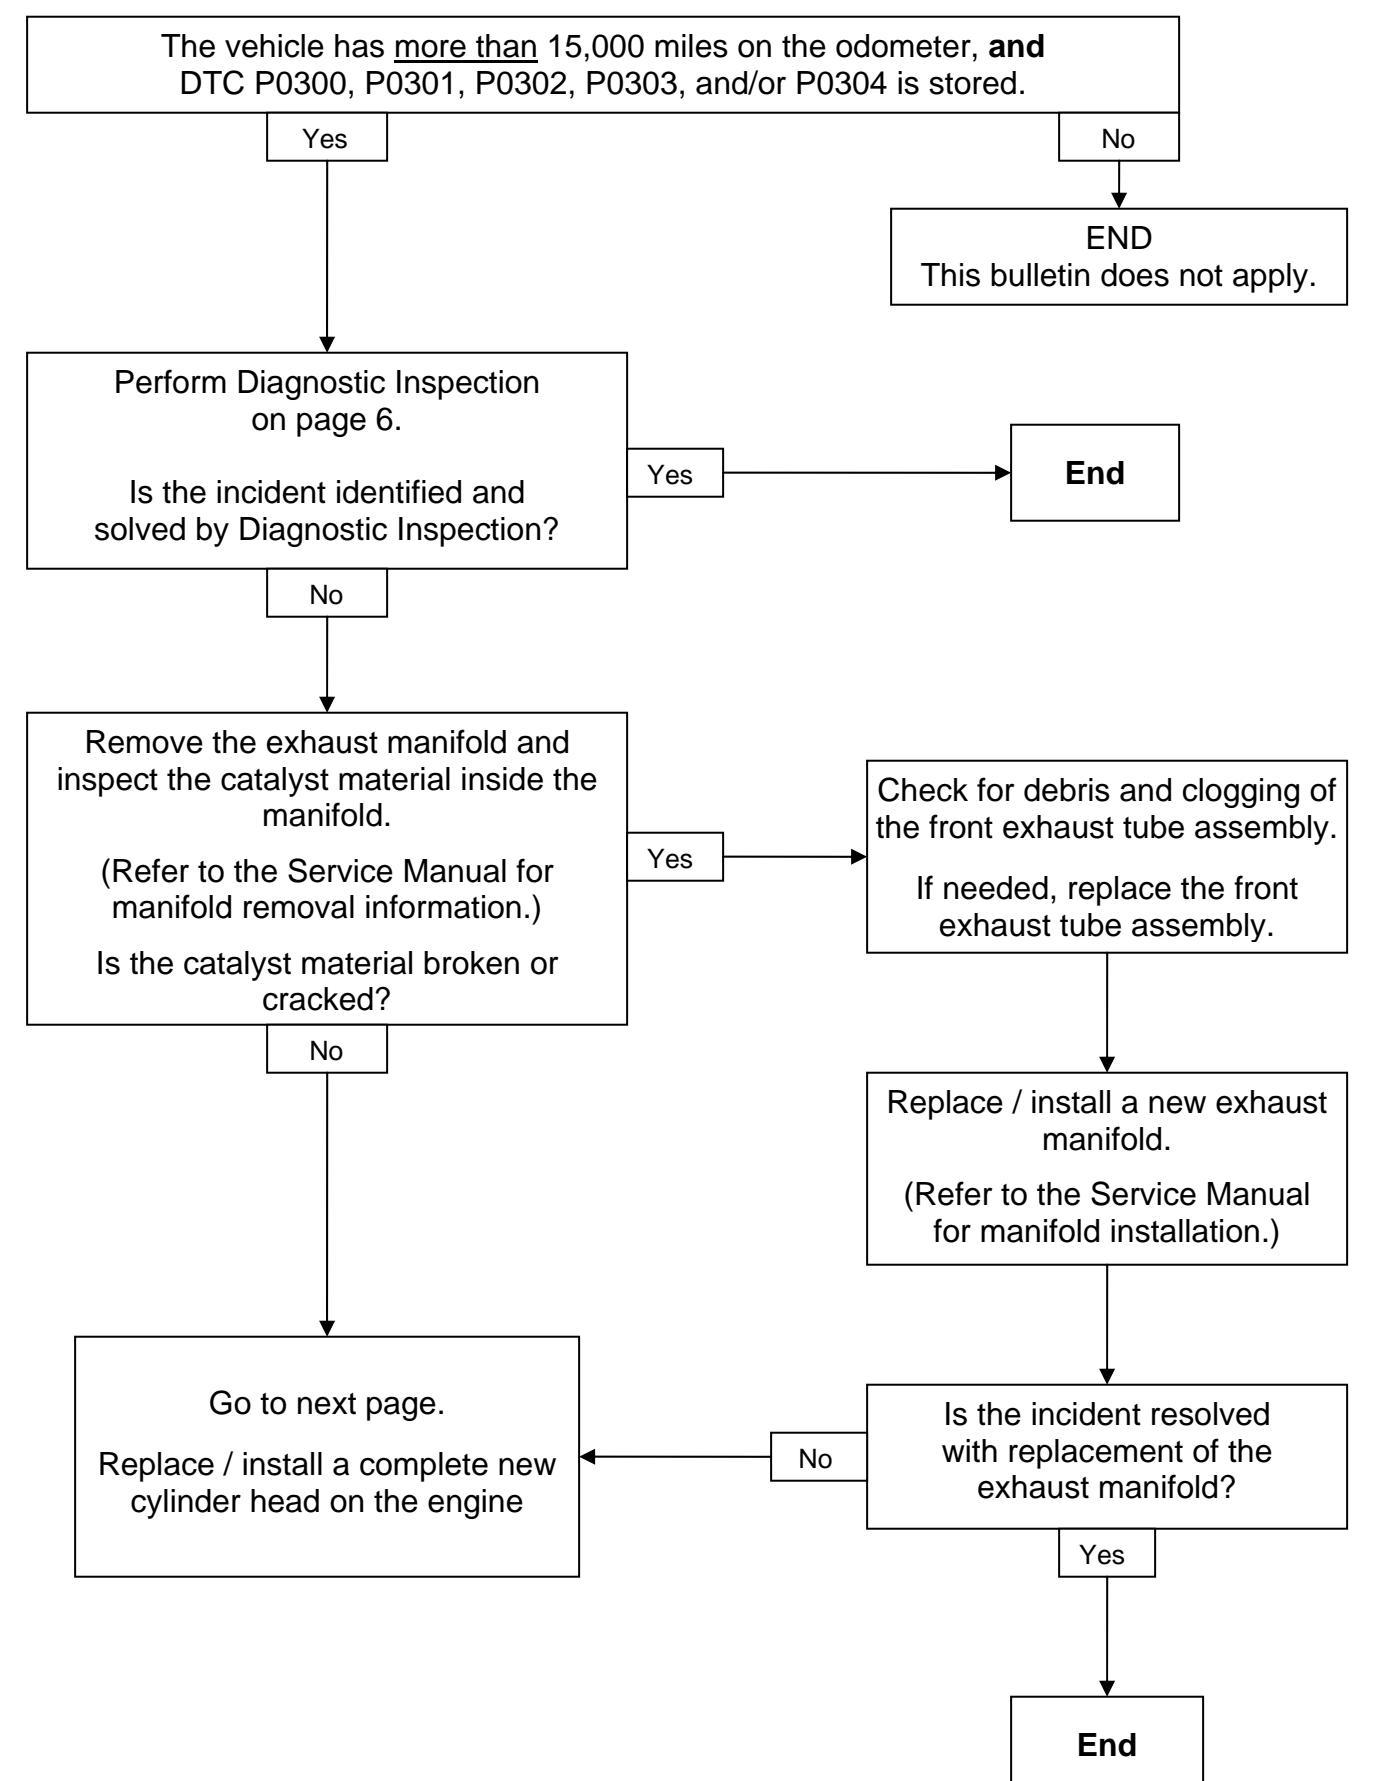
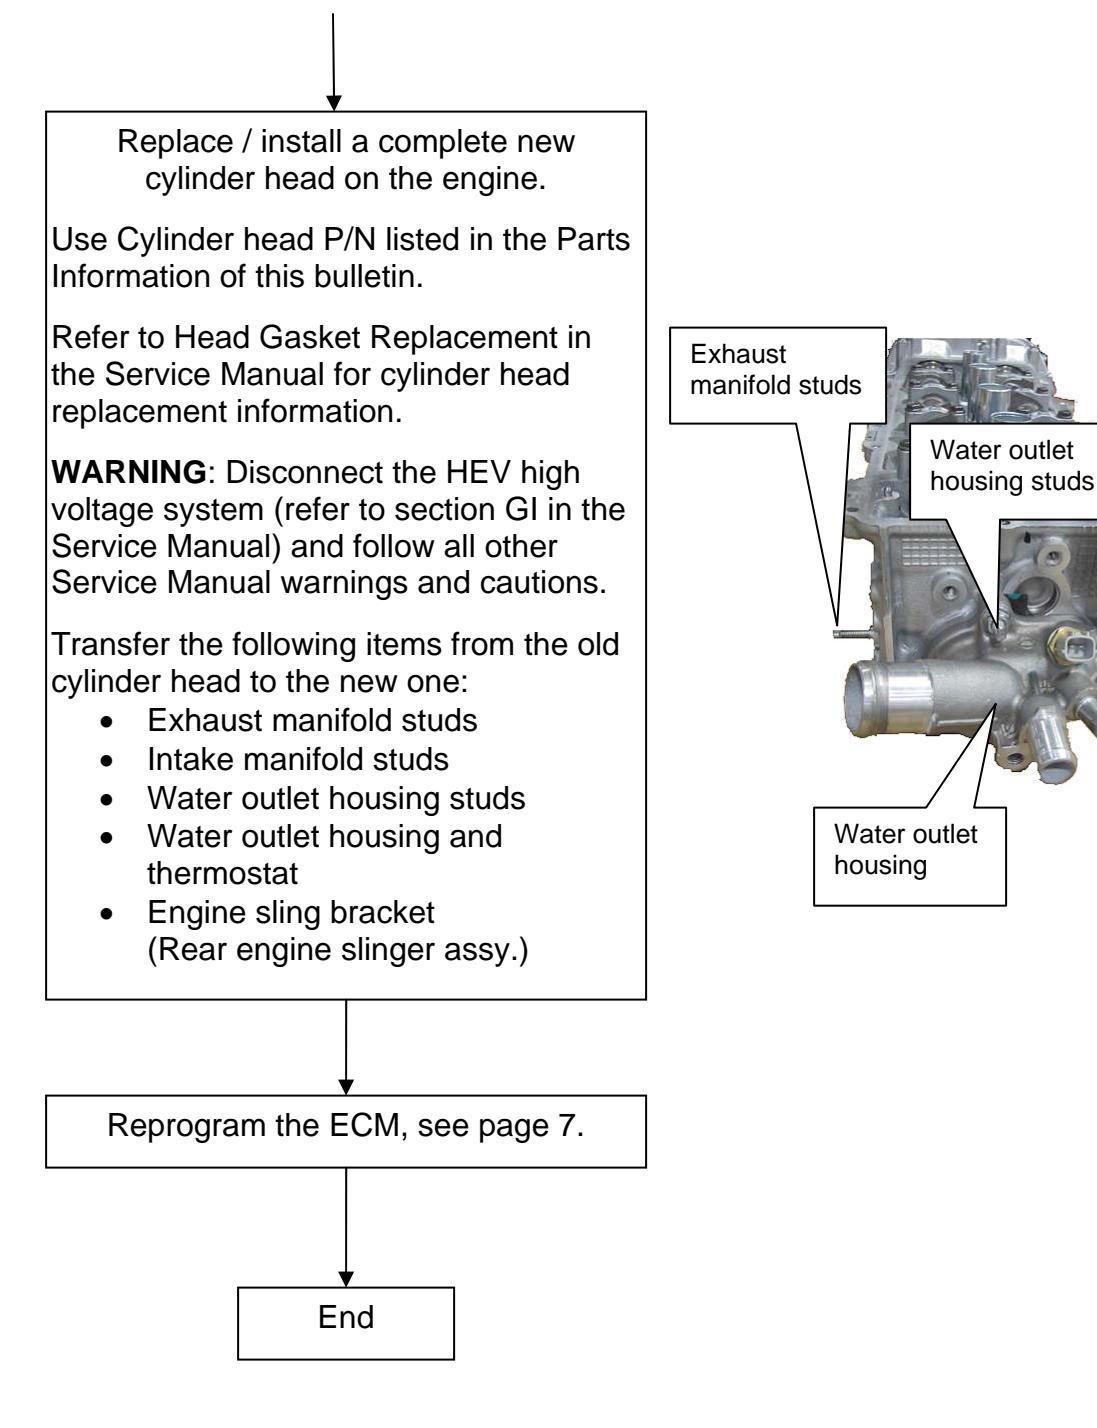
DIAGNOSTIC FLOW CHART

The vehicle has more than 15,000 miles on the odometer, and DTC P0300, P0301, P0302, P0303, and/or P0304 is stored.

- HEV vehicles have unique operating characteristics. The internal combustion engine has a higher frequency of start/stop cycles than a conventional vehicle.
- Under certain customer driving patterns this high frequency of start/stop engine cycles can result in increased carbon build up on the exhaust valves and/or exhaust ports. Sometimes these carbon deposits may cause the engine to run rough.
- The amount of carbon build up is highly dependent on the driving pattern of the customer.
- Carbon build up is not always the root cause of a rough running HEV engine.

Refer to the Diagnostic Flow Chart on page 4.
