SERVICE BULLETIN

Classification: EL08-004a	Reference: NTB08-044a	Date: March 4, 2009
------------------------------	--------------------------	------------------------

2007 – 2009 ALTIMA HYBRID 12V BATTERY FOR SERVICE

APPLIED VEHICLES: 2007 - 2009 Altima Hybrid (L32HV)

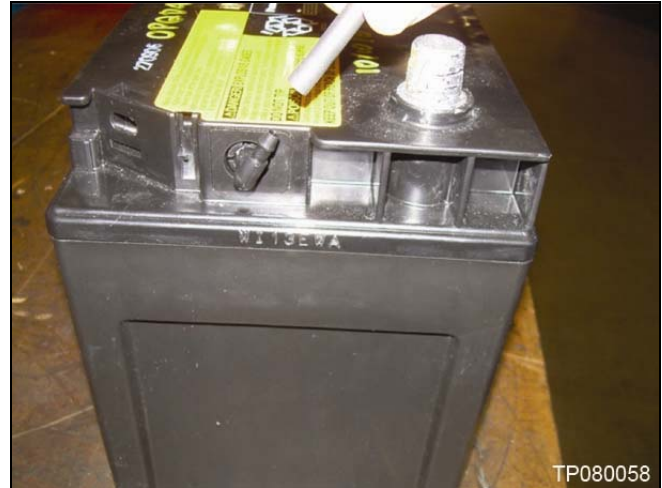
Figure 1

3. Remove the existing Panasonic battery from the vehicle and disconnect the vent tube as shown in Figure 1.

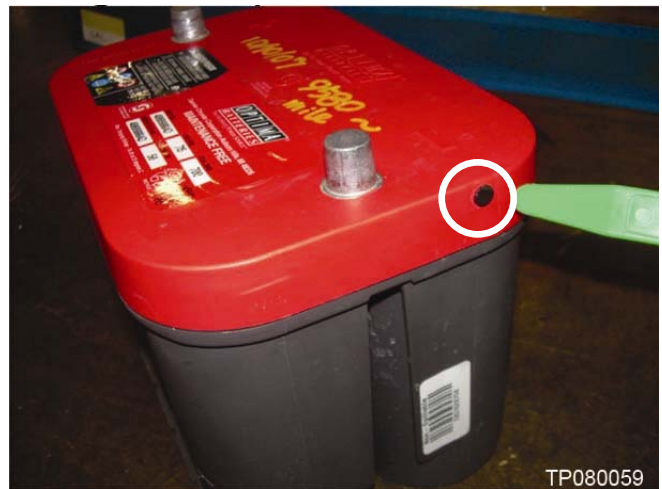
Figure 2

4. Unpack the Optima service battery and make sure the blind plug is installed securely in the vent hole close to the negative post side as shown in Figure 2.

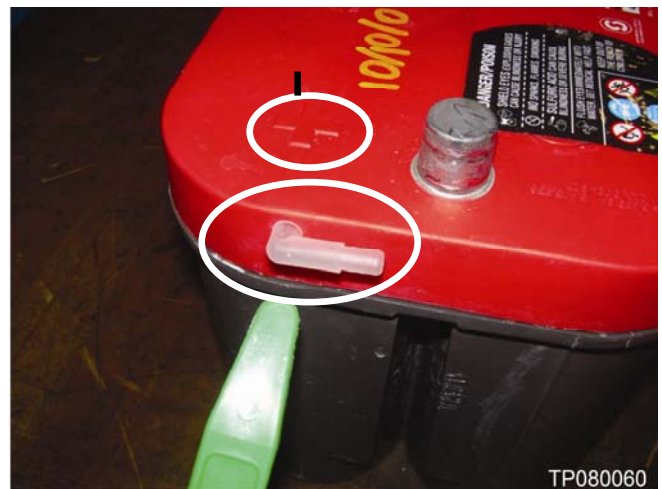
Figure 3

5. Install elbow fitting on the positive battery side as shown in Figure 3.

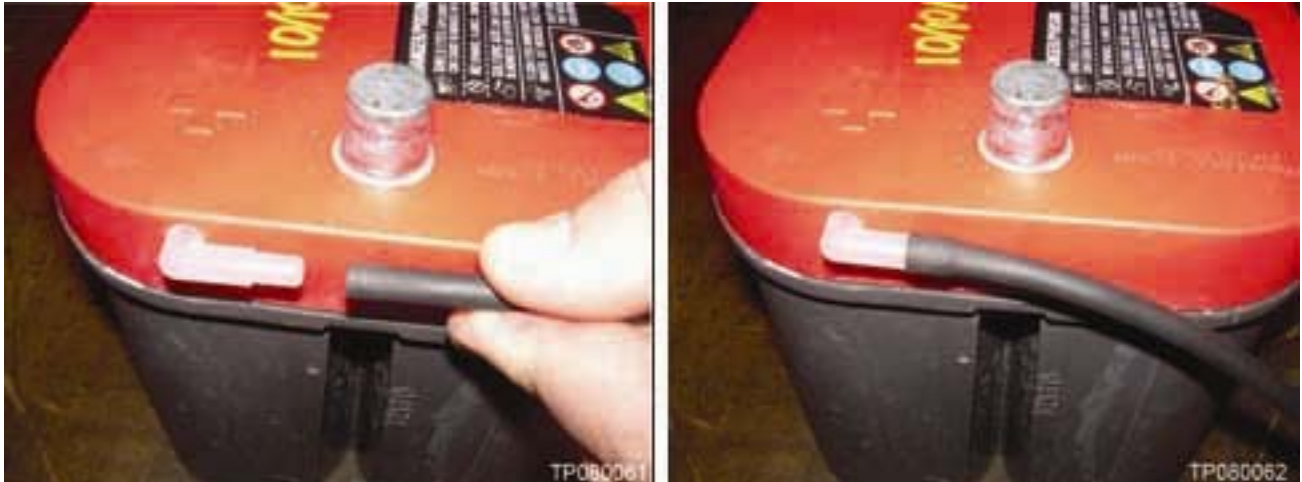
Figure 4

6. Attach the vent tube obtained from step 3. Make sure it is properly seated.

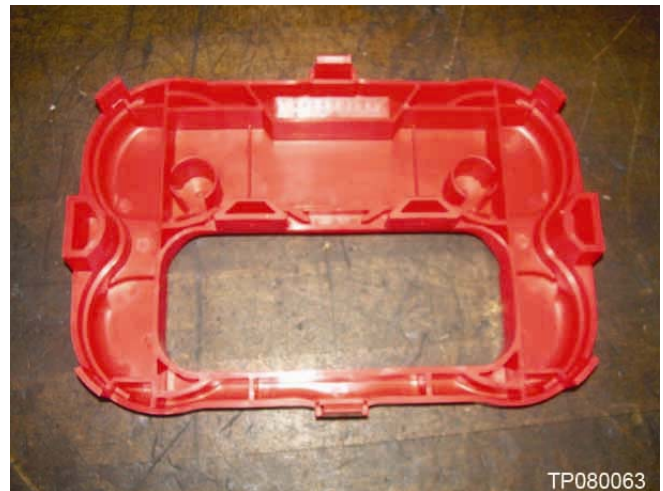
Figure 5

7. Place Optima battery spacer onto a flat surface as shown in Figure 5.

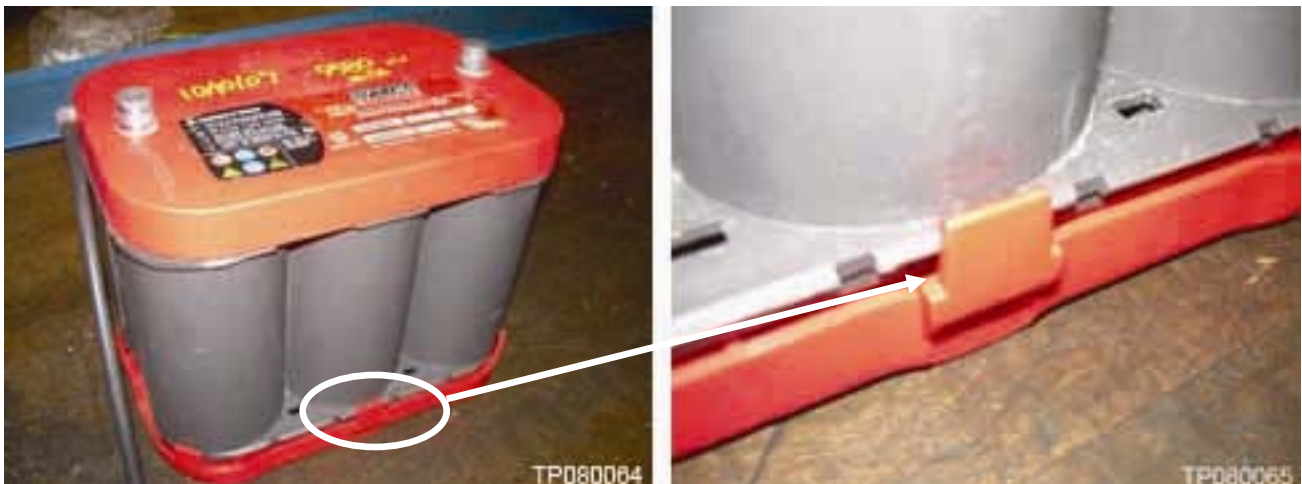
Figure 6

8. Mount battery onto spacer and make sure all the tabs are locked in place.

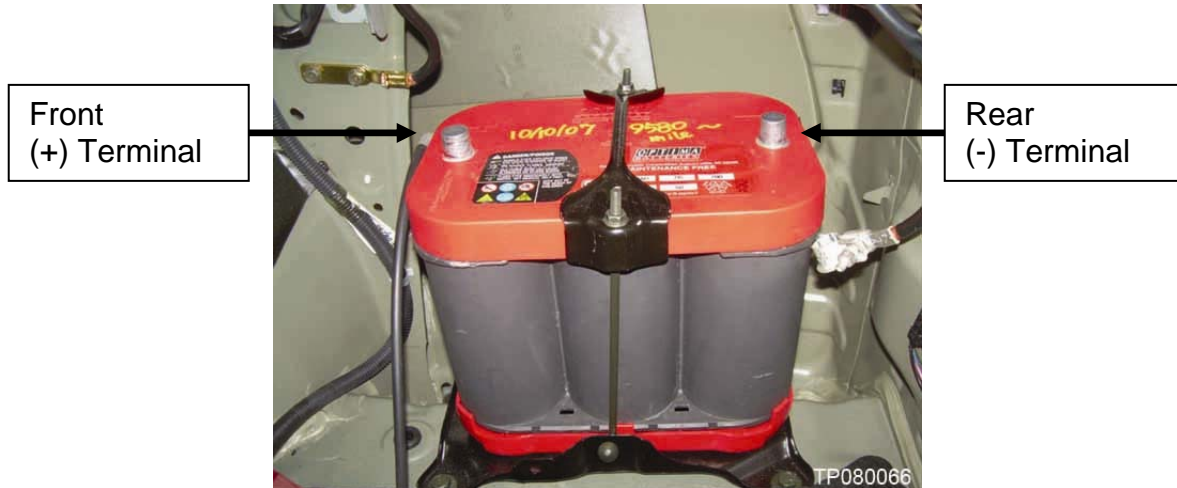
Figure 7

9. Mount completed assembly in vehicle as shown. Observe post orientation.

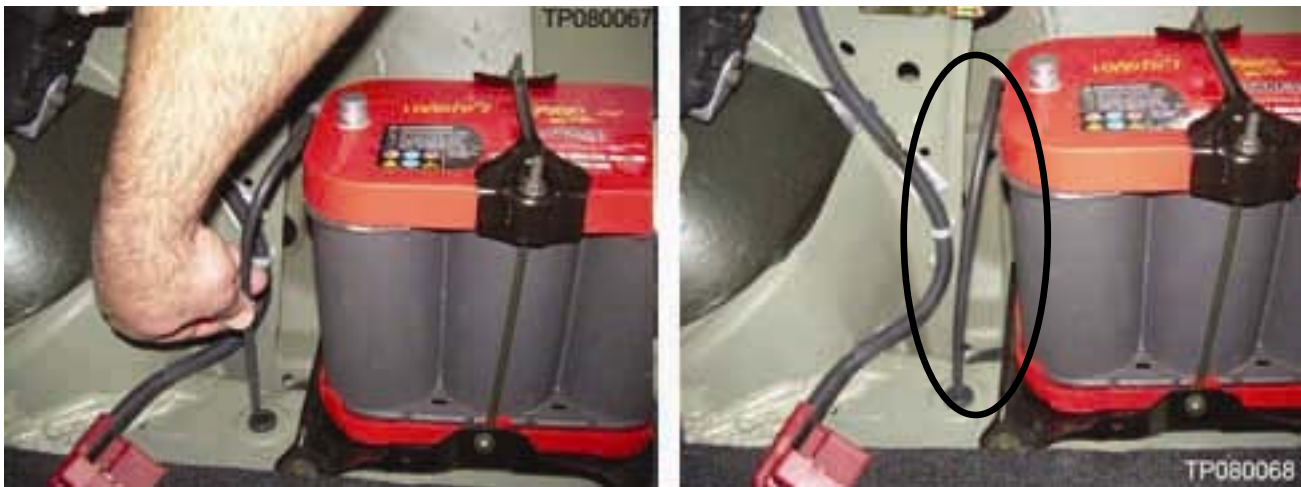
Figure 8

10. Insert vent hose into vent hole at least 20 mm or until there is no slack in the vent tube.

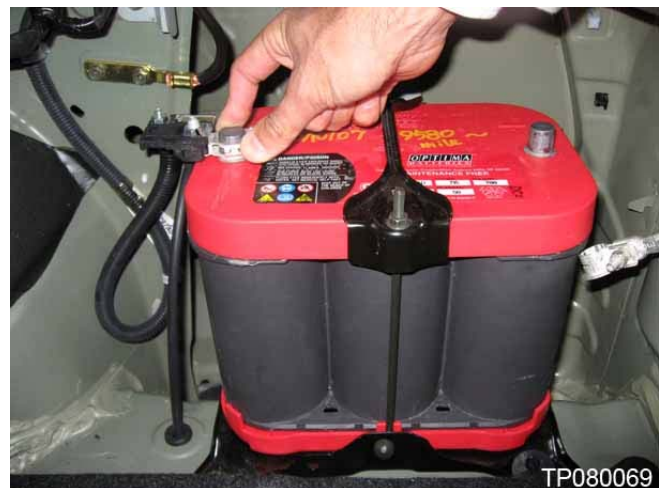
Figure 9

11. Secure positive (+) and negative (-) terminals to the battery. Press on terminal while securing to insure proper fit.

CAUTION: When connecting the new battery, connect the positive (+) cable first and then the negative (-) cable.

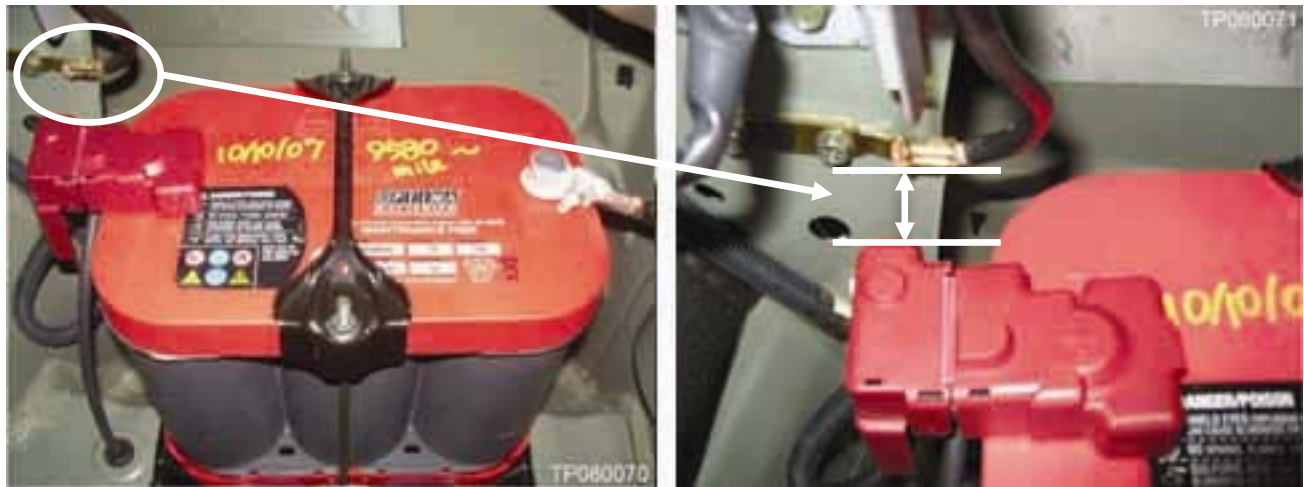
Figure 10

12. Create a clearance of at least 10 mm between positive (+) terminal and body ground cable.

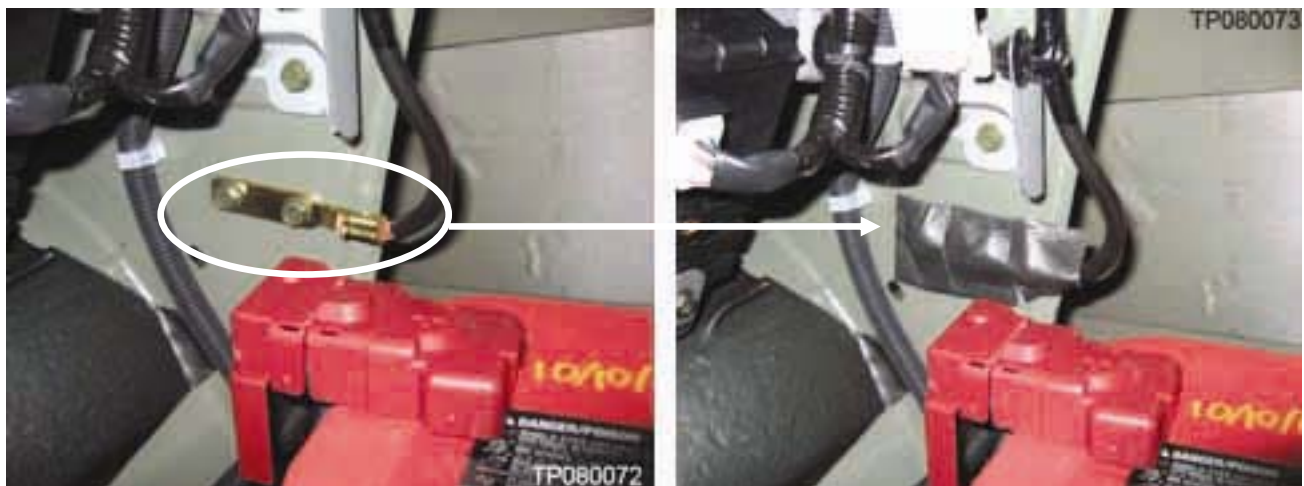
Figure 11

13. Cover body ground cable with adhesive backed pad (included in Squeak and Rattle repair kit J-43980).
