# SERVICE BULLETIN

Classification: EL10-030	Reference: NTB10-139	Date: November 23, 2010
-----------------------------	-------------------------	----------------------------

## ALTIMA SEDAN, COUPE, AND HYBRID; ENGINE NO CRANK / NO START

**APPLIED VEHICLES:** 2007 – 2010 Altima Sedan (L32) with CVT only  
2008 – 2010 Altima Coupe (CL32) with CVT only  
2007 – 2010 Altima Hybrid (L32HV)

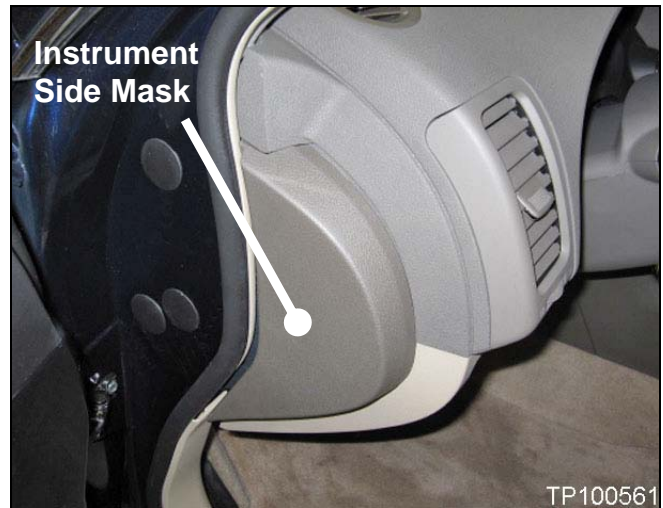
Figure 1

3. Remove the driver side instrument side mask (see Figure 1).

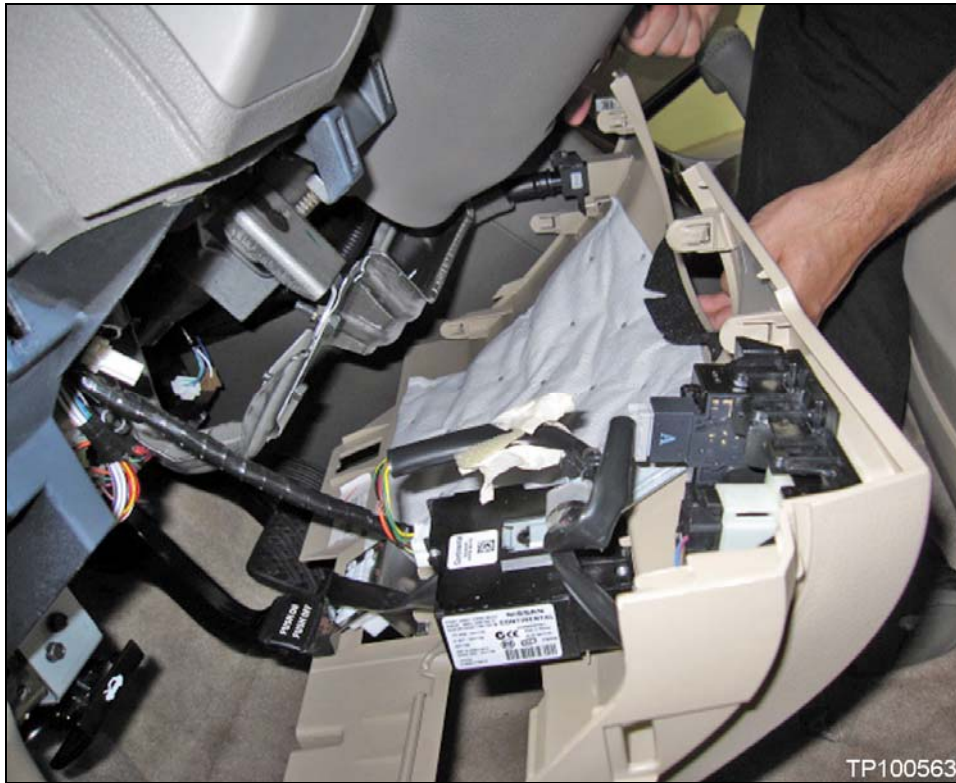
Figure 3

6. Detach the driver side instrument lower cover (see Figure 3).

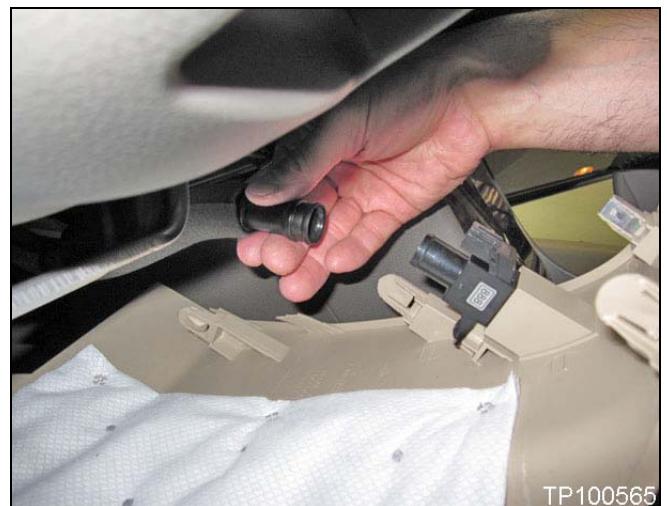
Figure 4

7. Disconnect the in-vehicle sensor tube and connector (if so equipped) See Figure 4.

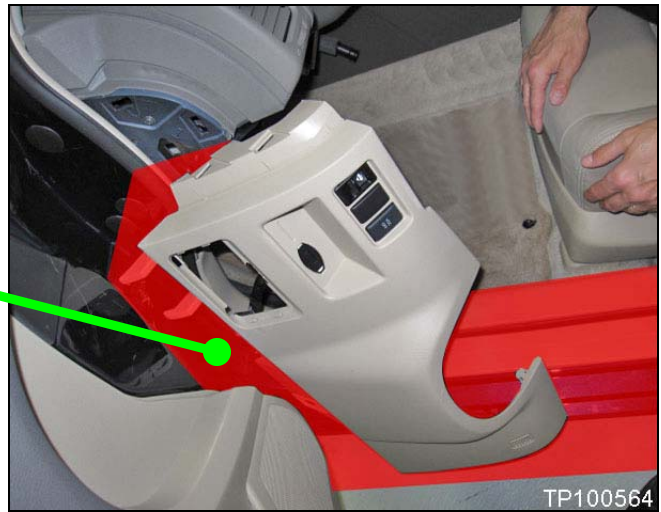
Figure 5

8. Swing out of the way and position the instrument lower cover outside the door opening (see Figure 5).
- Use suitable protection between the instrument lower cover and surrounding areas.

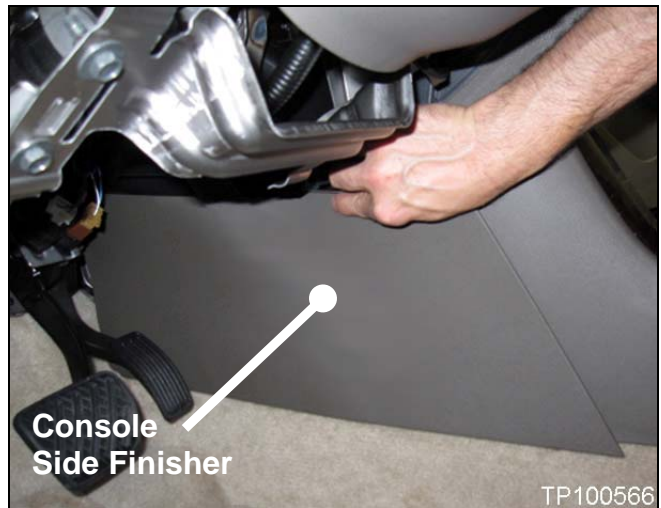
Figure 6

9. Remove the driver side console side finisher (see Figure 6).

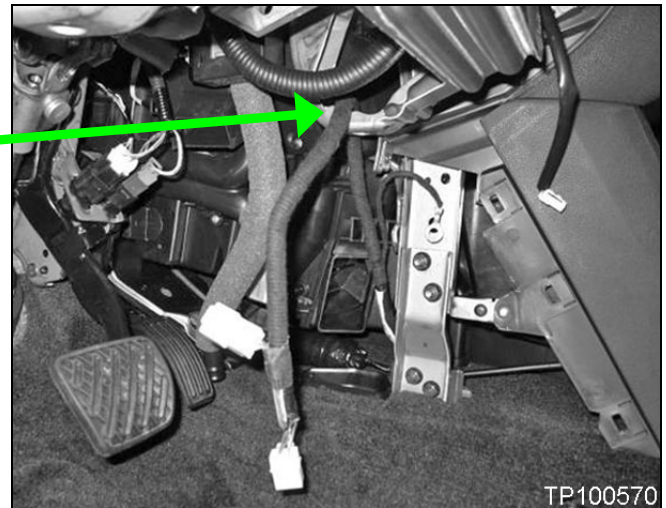
Figure 9

12. Route the sub-harness over the top of the steering member stay (see Figure 9).

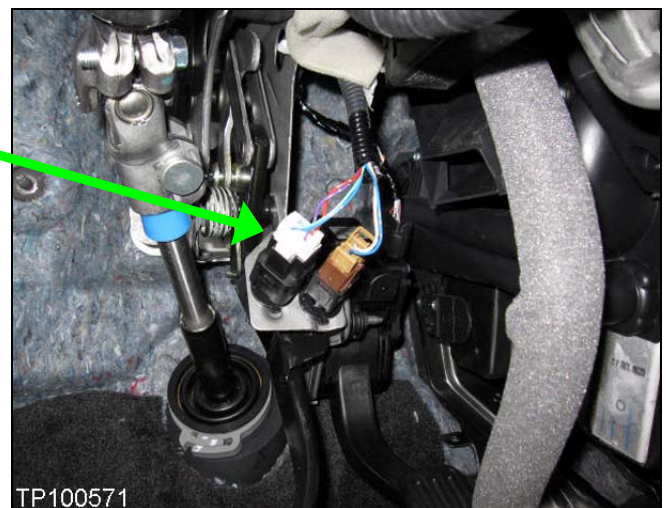
Figure 10

13. Disconnect the E38 stop lamp switch connector, and then replace the stop lamp switch (see Figure 10).

**NOTE:** Old and new stop lamp switches are not interchangeable. The stop lamp switch listed on Page 2 in **PARTS INFORMATION** must be used when installing the sub-harness.

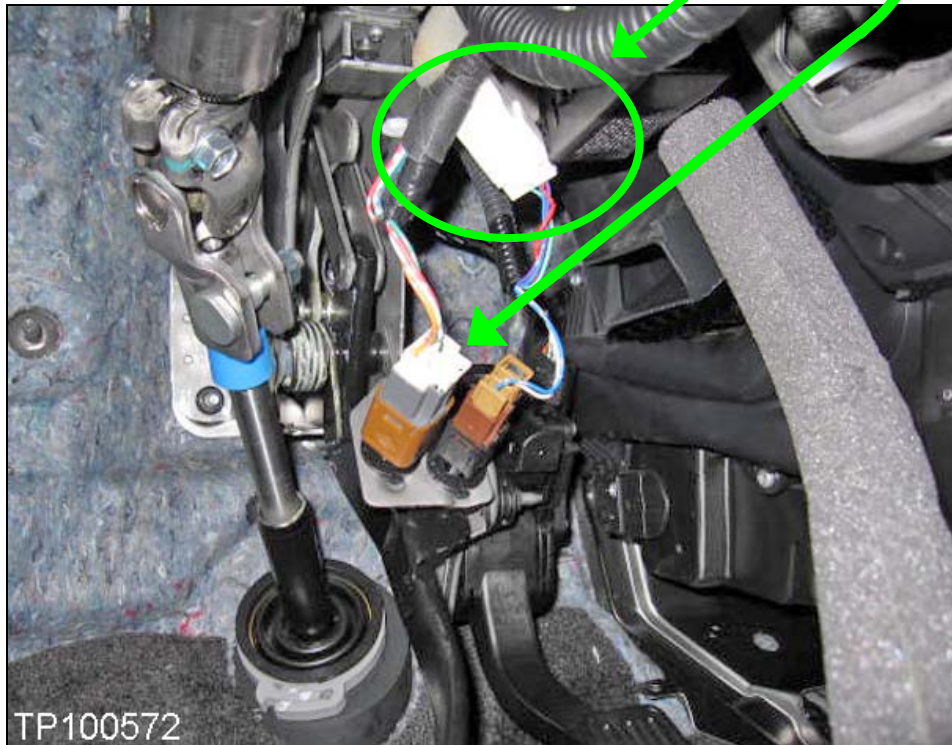
Figure 11

14. Connect connector 'A' to connector E38 (see Figure 11).

15. Connect connector 'B' to the stop lamp switch (see Figure 11).

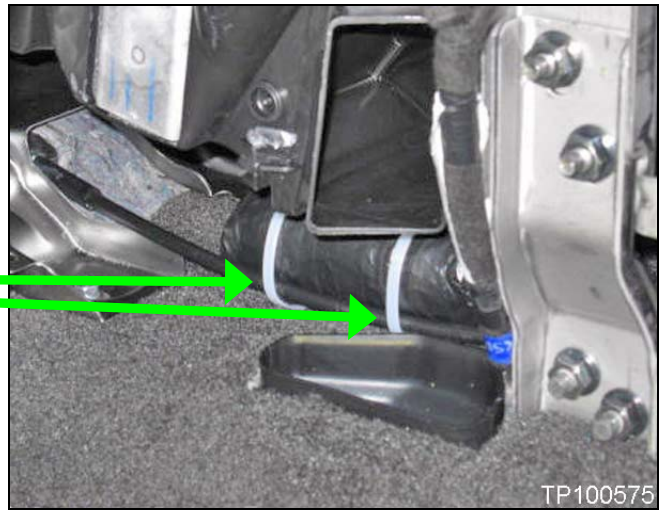
Figure 13

17. Secure the relay pack of the sub-harness to the shift cable where shown in Figure 13.

- Use two (2) tie straps (P/N 24216-W1000).

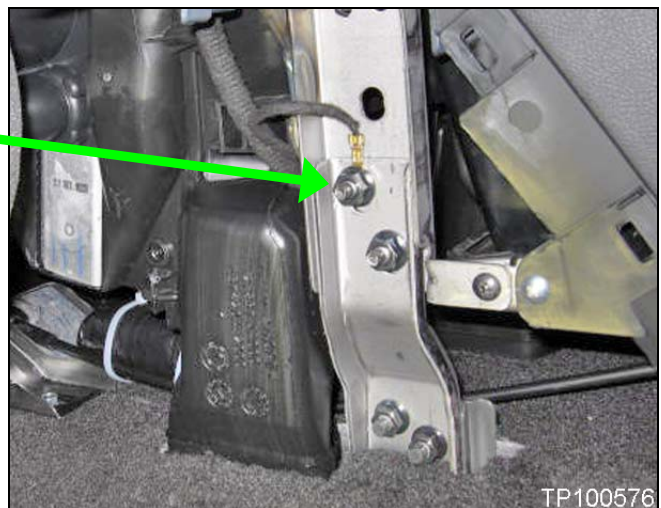
Figure 15

18. Remove the nut, install the ground eye loop on the stud, and then reinstall the nut where shown in Figure 15.

- Nut torque: 14 – 20 N•m (1.4 – 2.0 kg-m, **123.9 – 177.0 in-lb**)
