EC10-005a

NTB10-056a

June 25, 2010

2007 – 2010 ALTIMA HYBRID; DTC P0300 – P0304

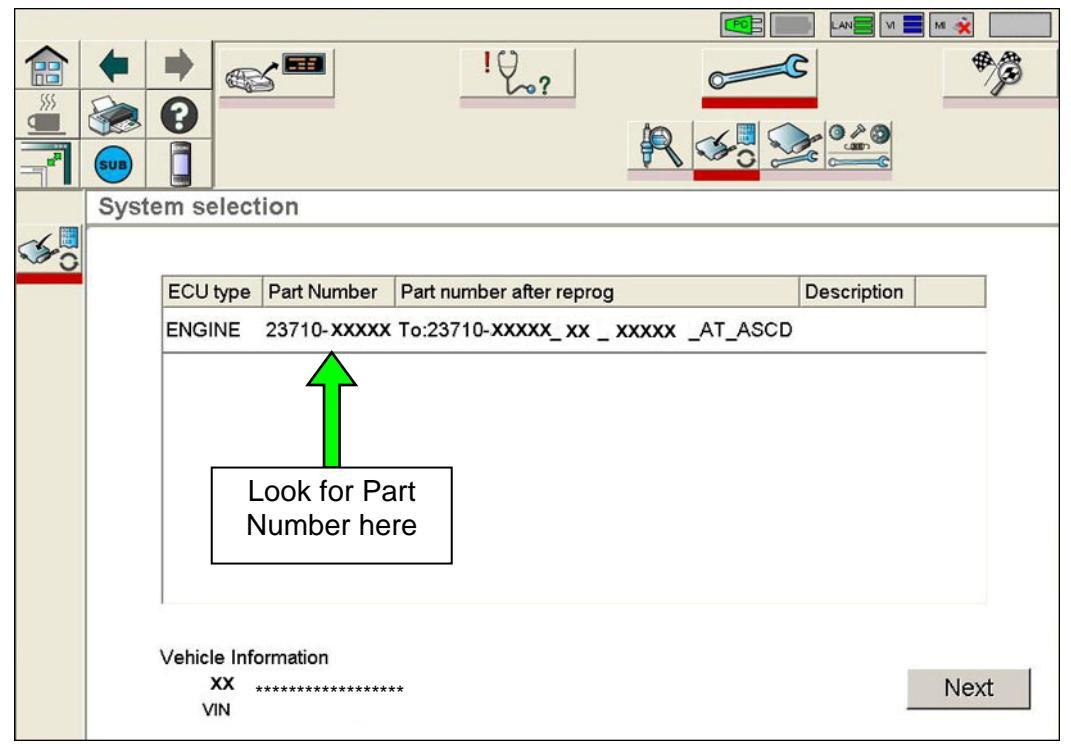
Figure 1

- B. Compare the Part Number you wrote down to the numbers in the **Current ECM Part Number** column in **Table A** below.
 - If there is a <u>match</u>, this <u>bulletin applies</u>. Continue with the reprogramming procedure.

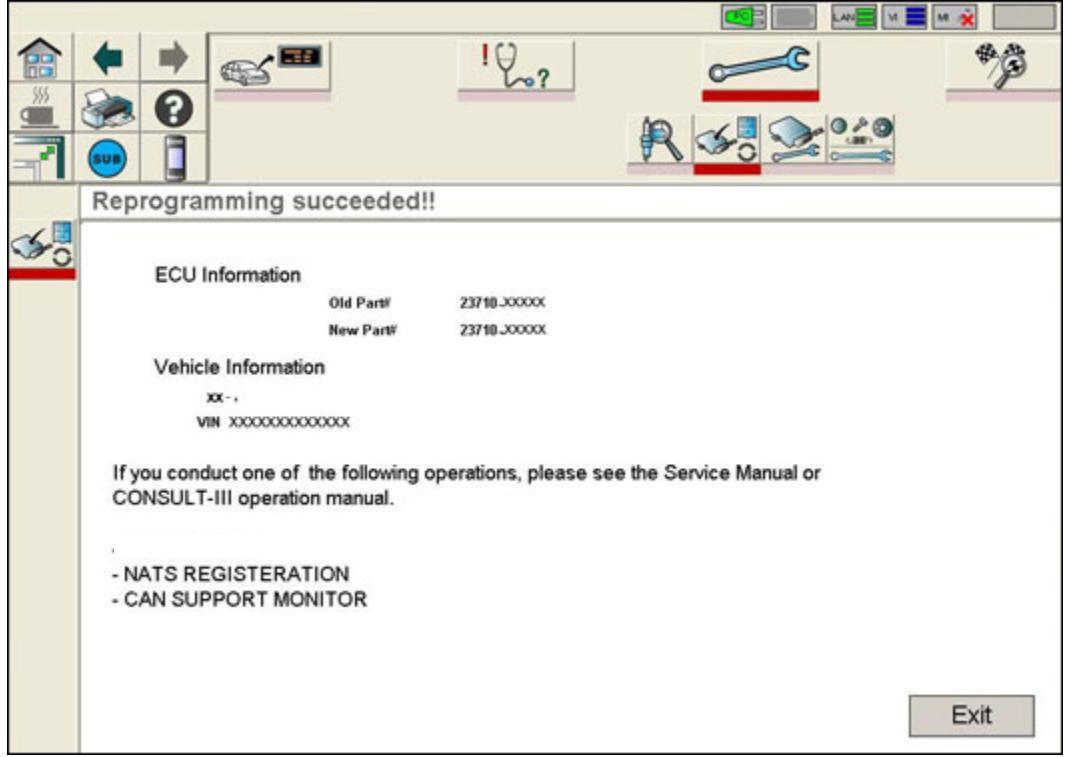
3. If this bulletin applies and you have performed ECM reprogramming; when reprogramming is complete, the screen in Figure 2 displays.

NOTE: If the screen in Figure 2 does <u>NOT</u> display (reprogramming does <u>NOT</u> complete), click here. This links to the ECM Reprogram Interruption Recovery General Procedure.

• Print this screen (example Figure 2) and attach it to the repair order for warranty documentation.
